Case Study

Centrifugal gas compressor train overhaul

Major compressor outage successfully completed on a platform in the northern sector of the North Sea

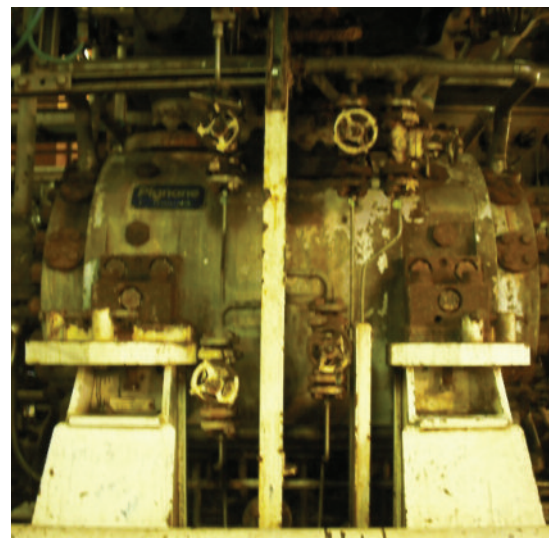
Erosion in first stage eye seal diameter.

As part of the overhaul, the centrifugal compressors had their barrels removed from the casing, top halves lifted and the rotors removed. The units were rebuilt utilising new spare parts and the associated spare compressor rotors. The reciprocating compressor had only a relatively minor overhaul with new pistons and piston rods fitted together with a new set of valves. Upon completion, the units were successfully commissioned and the empty kit boxes and ex-service rotors returned to Weir for replenishment and inspection respectively. Following the inspection of the rotors it was evident that severe erosion had occurred on the first stage eye seal diameter on the LP rotor as shown in the picture to the left.

To minimise costs, the seal diameter was repaired through nickel equivalent HVOF techniques negating the requirement to replace the impeller completely. Along with the impeller repair, the balance drum on the LP rotor was replaced together with seal sleeves on both rotors, the repaired seal diameter is shown in the photograph to the left. After refurbishment both rotors were sealed into foil vacuum bags and packed into wooden crates for long term storage, available for the customer at their next outage.

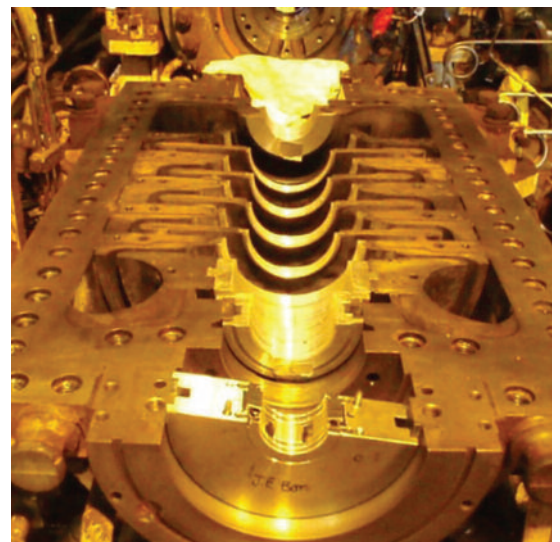
Eye seal diameter following repair.
