Hydrogen compressor re-build

# Major restoration of Nuovo Pignone BCL 353 hydrogen compressor successfully completed in seven months

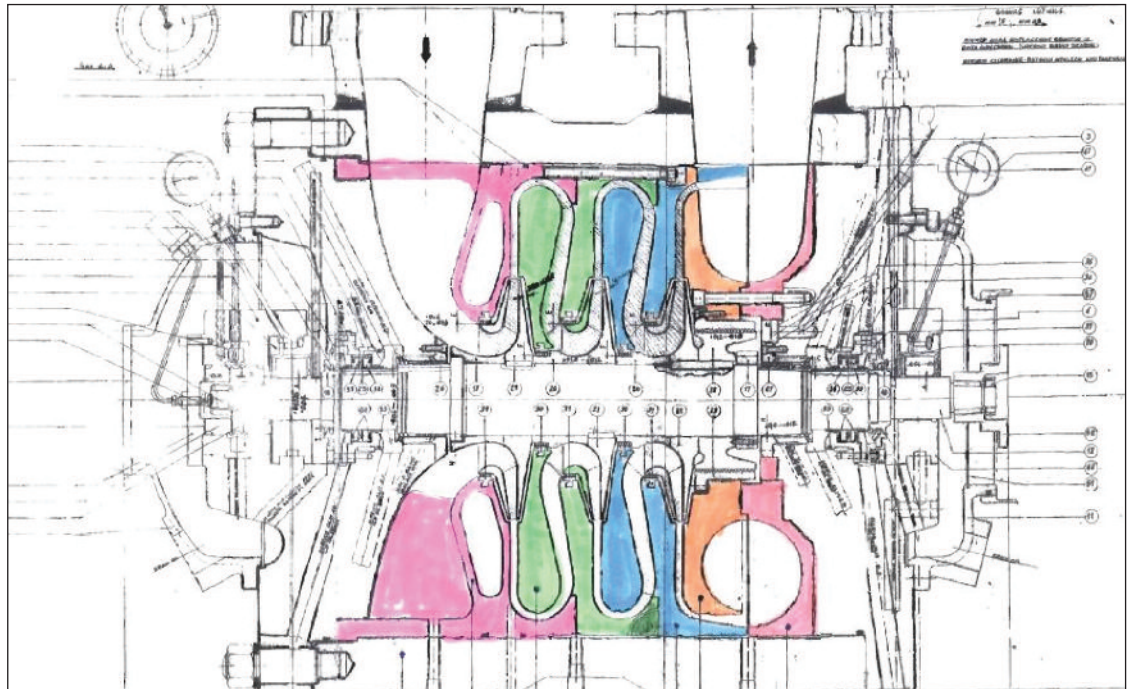
Each of the cast components had cracks as severe as that shown in this photograph.

Once the bundle was removed from the case, the outside of the return channels broke clean away from the diaphragms.

A previous explosion in the suction pipework had cracked all of the static cast iron aero components rendering the compressor inoperable.

The sectional view highlights the new parts that were manufactured by Weir Turbomachinery.
