Case Study

Natural gas compressor re-rate

Natural gas compressor re-rate in South East Asia

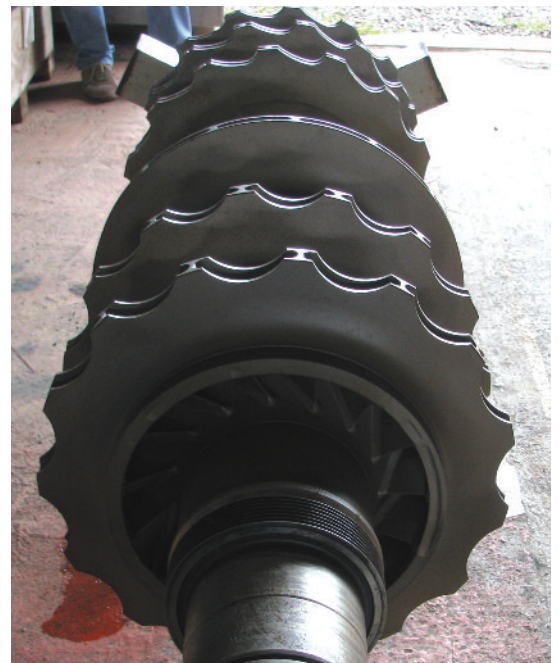
The resonance issue could not be resolved since it would require manufacture of a new impeller. Instead, the impellers were scalloped by the OEM (see Figure 1) and the maximum running speed (MCS) was reduced. The excessive scalloping and the reduced speed range reduced the compression capability of the compressors, while decreasing efficiency levels.

Figure 1. Scalloped impeller on original rotor.

The failures on the compressors were associated with fouling and resonance. Metallurgical analyses on failed impellers suggested that the broken impellers failed due to fatigue. Modal analyses clearly suggested that there was impeller natural frequency inside the speed range of the compressors. Traces of mercury were found inside the gas although no direct mercury-related failure was reported.

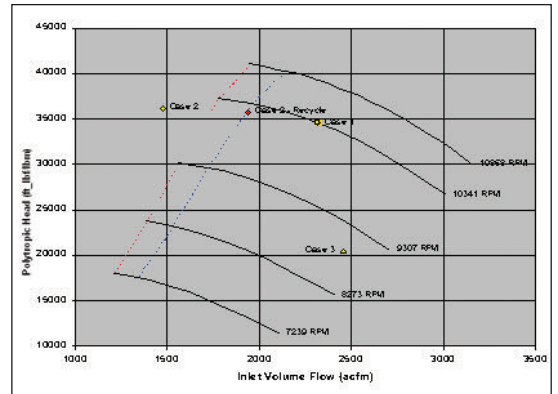
Figure 3. High Pressure (HP) section performance map.

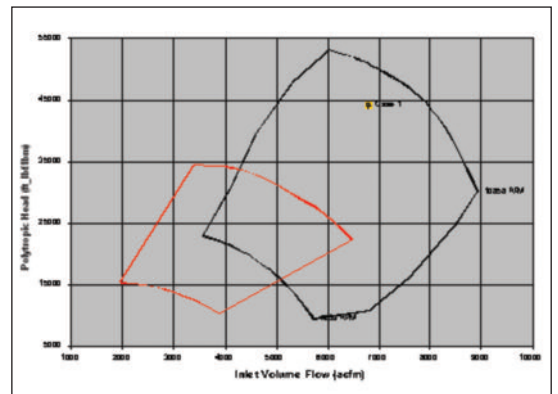
Figure 4. Existing vs re-rate LP performance map.

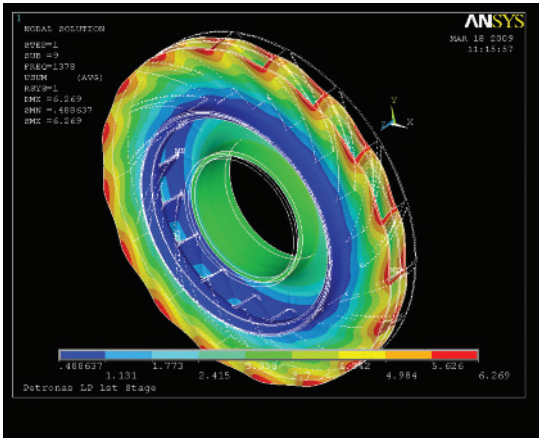
Figure 6. LP 1st stage modal analysis – 9th mode.

The impeller modal analysis was carried out after all aerodynamic and stress analyses were completed. The modal analysis assured that there were no impeller structural modal frequencies inside the running speed range of the compressor. The calculated frequencies were later verified by ring testing.

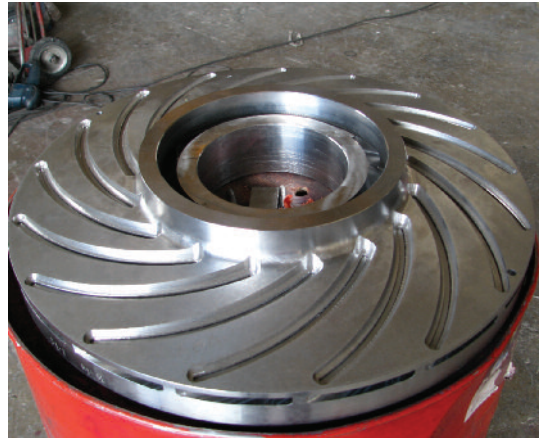
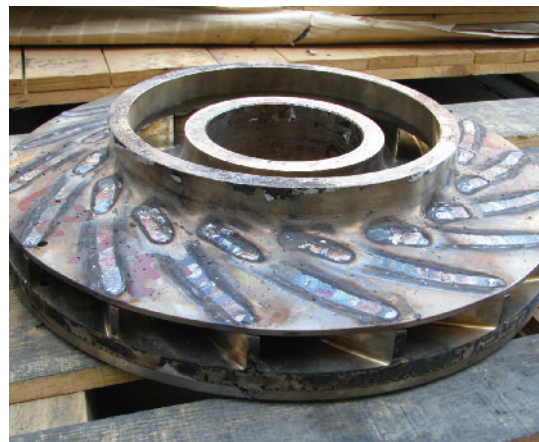
Hub and shroud weld prep.

Post weld.

Figure 7. Impeller manufacturing steps.

The impellers were milled as two pieces; the blades were milled into the hub and a shroud with weld slots was manufactured. The blade leading edges were welded with stellite weld rods to protect against erosion in the field. After heat treatment, the impeller was finish-machined, NDT inspected, balanced and spun to 115% of the Maximum Continuous Speed.

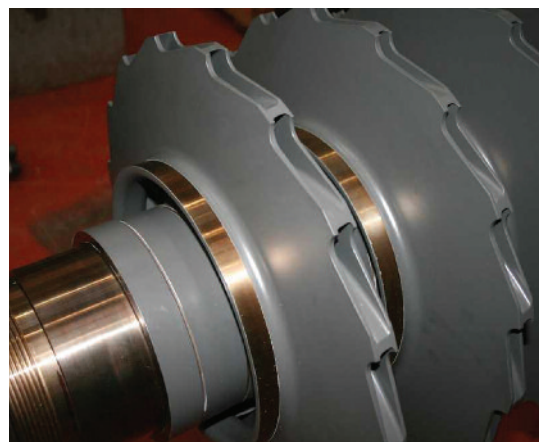
Figure 8. Teflon coated rotor.

Following assembly and sequential low-speed balance, the rotor was coated by a Teflon coating to protect against corrosion. The rotor was then high-speed balanced.

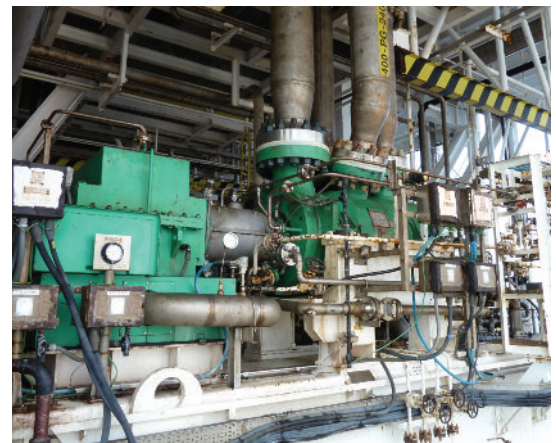
Figure 12. First unit commissioned at site.

The first unit was shipped to site and was commissioned on the platform in mid-2011. The unit was immediately out on-line, offering significant power savings compared to the existing units.
