TECHNICAL BULLETIN

Subject: Three Piece MSIV Stem Issues

Bulletin No. 10.0 08/10

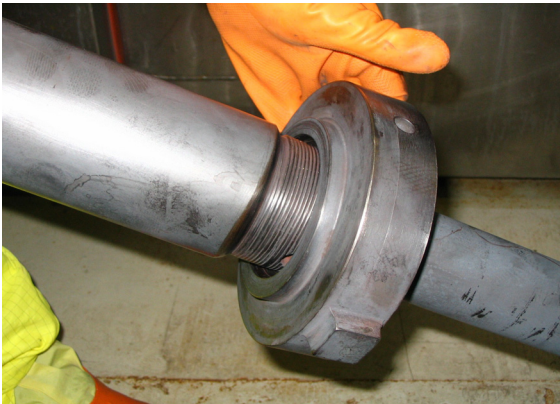
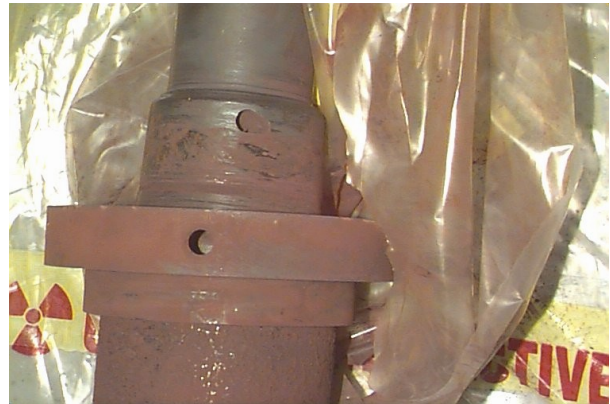
The three piece MSIV stem has been an issue since the original design of the MSIV. The original design incorporated a stem with a threaded on top spring seat with tack welds at the interface of the two parts. When it was discovered that the tack weld cracked, a dowel pin and then a taper pin was used to lock the two parts together. These too have failed with the result of the top spring holder coming loose and loosening the solid connection between the poppet and stem. The two pictures below illustrate the results of the parts separating.

This is not a safety issue as the valve will still close and seat tightly, but it does allow for accelerated internal wear.

The solution to the problem was to manufacture the stem from a one piece forging. This eliminated the screwed and pined connection, which completely eliminates the possibility of the spring holder loosening. This redesign also incorporates the anti-rotation lugs as part of the forging, which also eliminates the past practice of welding them on the edge of the spring holder.

The appearance and shape of the new redesigned stem is identical to the old fabricated stem and the form, fit and function are unchanged.
